Enclosed please find three (3) pages of proposed drawing corrections for Figures 1-3, 5, and 6. The proposed corrections are highlighted in red. A letter to the Official Draftsperson has also been provided with a copy of the proposed drawing corrections. The Examiner's approval is respectfully requested for the proposed changes to the drawings shown in red ink. The following corrections are made to Figures 1-3, 5, and 6.

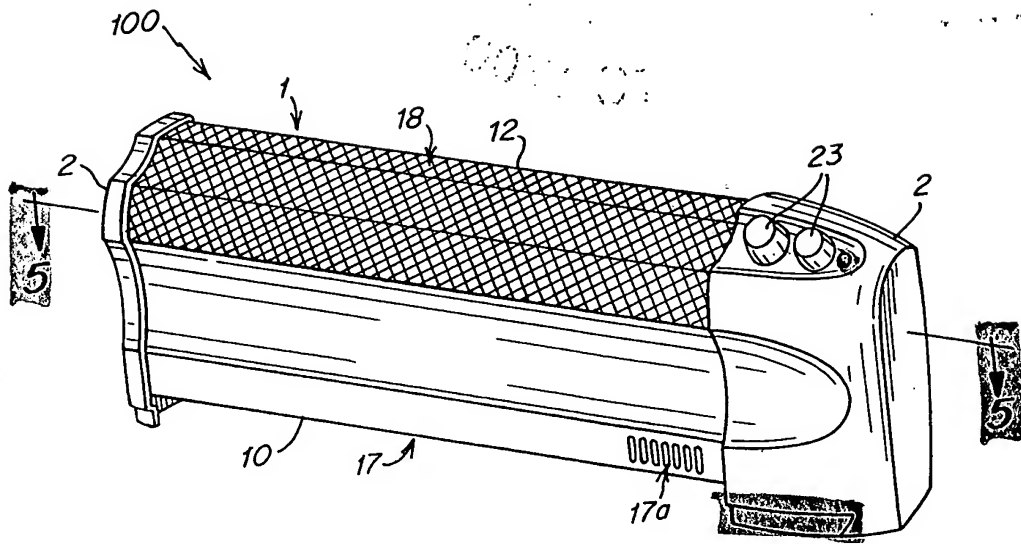
Fig. 1

Callout for sectional view A-A has been changed to sectional view 5-5.

An indicator light has been added near the user interface 23 to be consistent with originally filed Figure 4.

An ornamental cutout has been added at the lower front facing edge of the left hand end cap, shown at the right hand side of the picture to be consistent with originally filed Figure 4.

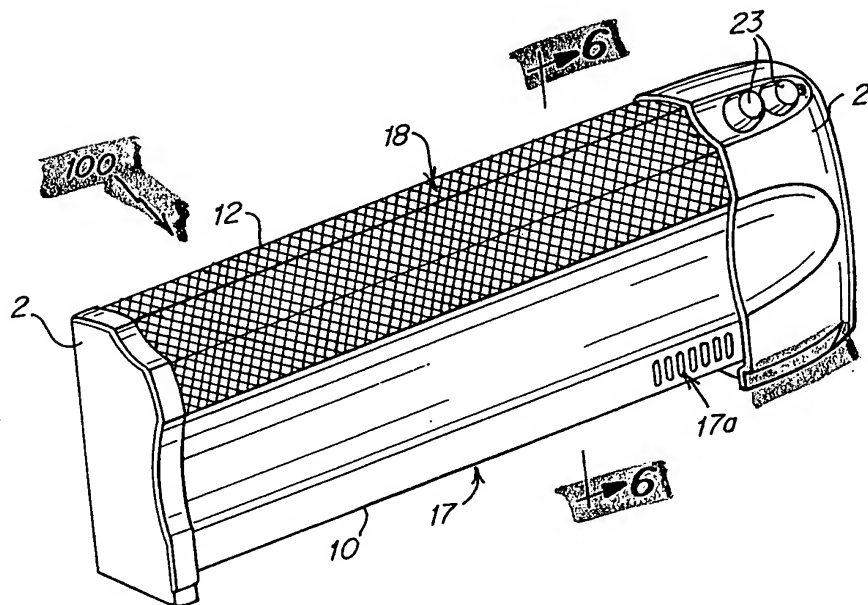
Fig. 2

Callout for sectional view B-B has been changed to sectional view 6-6.

A callout for a heater, item 100 has been added.

An indicator light has been added near the user interface 23 to be consistent with originally filed Figure 4.

An ornamental cutout has been added out the lower front facing edge of the left hand end cap, shown at the right hand side of the picture to be consistent with originally filed Figure 4.

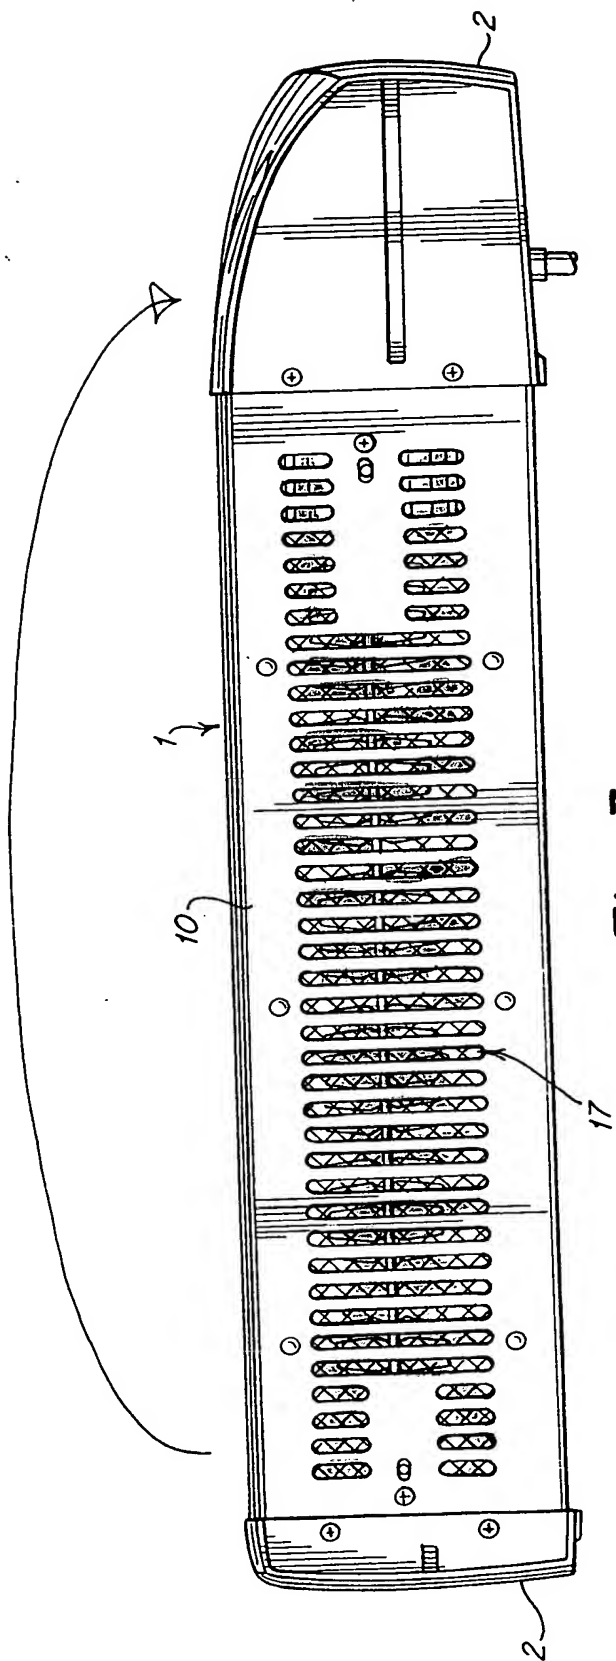
Fig. 3

The entire view has been rotated 180°.

The grill is now shown through the air inlet 17.

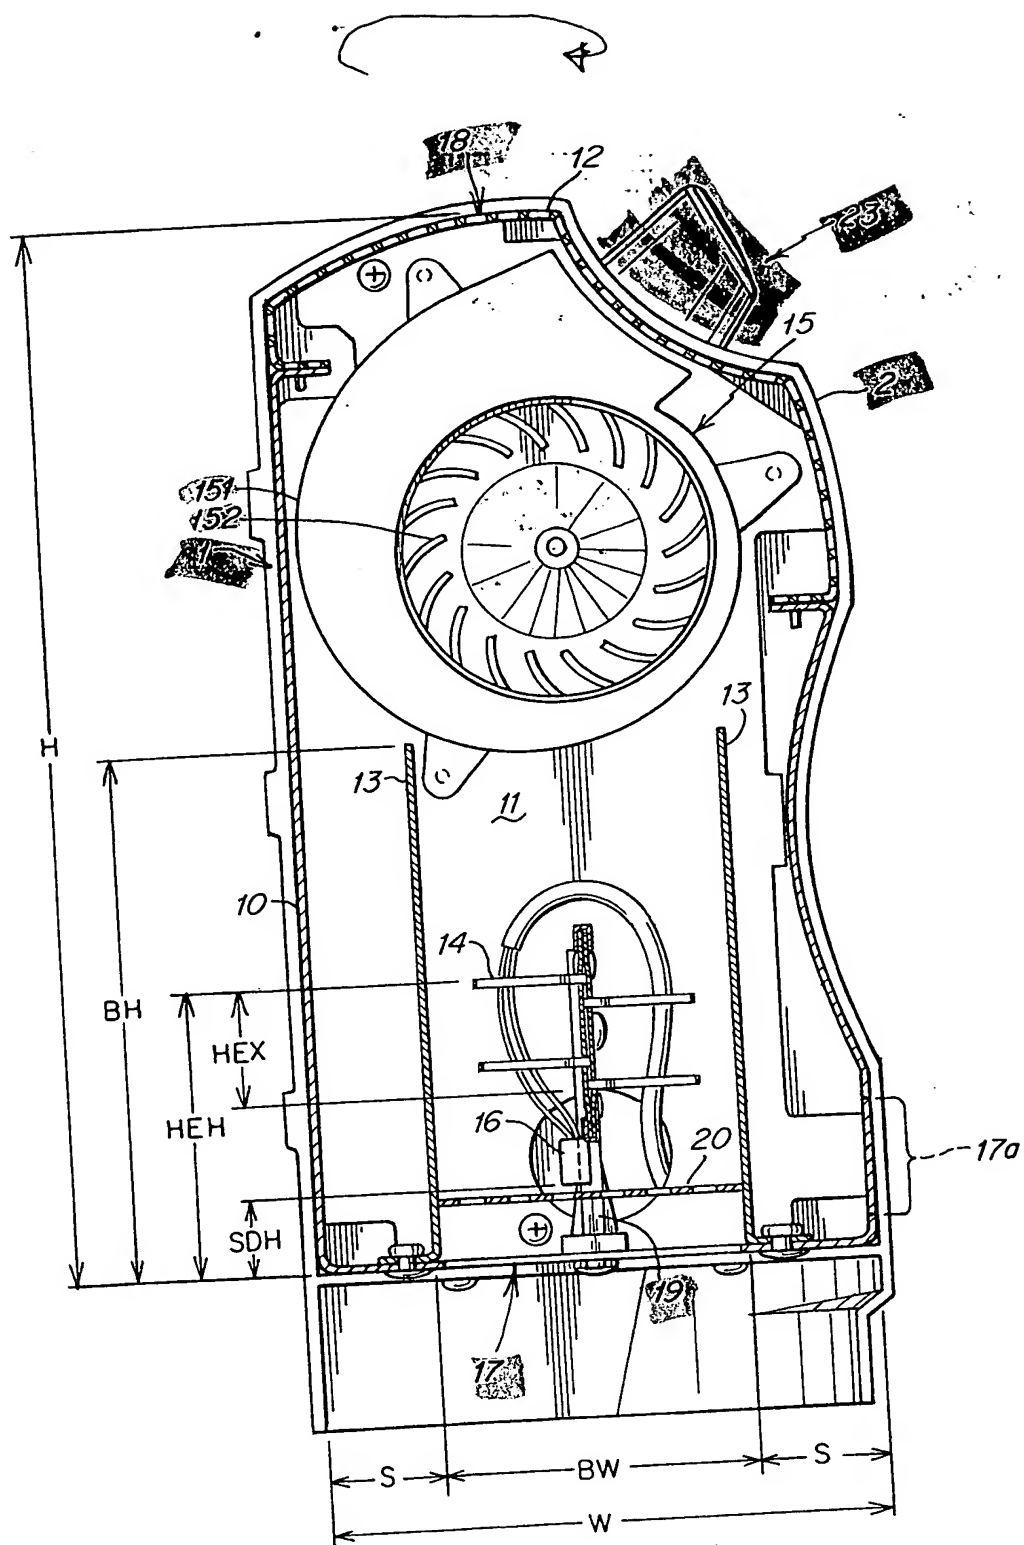
Fig. 6

Figure 6 is a cross-sectional view taken along lines 6-6 as shown in Figure 2.
